Manhole Inspection Summary

Manhole # S03UU1021MH

Insp Date: **7/22/06 8:22 AM**

Location Address: **5806 PARK HEIGHTS AVE**

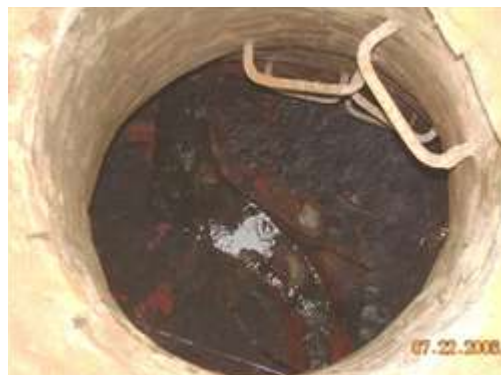
Top View

Frame leaks. Adjsutment loose brick.
Adjustment, Corbel, and Barrel infiltration.
Bench debris. Channel debris.

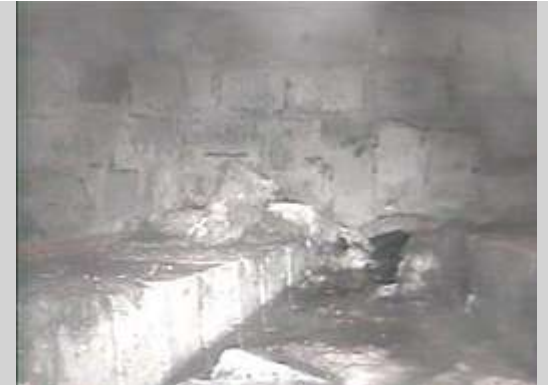
8 in. Circular Gravity Sewer Pipe Out @ 12 O'Clock

Comments **O12 pipe is 75% clogged with debris. Cleaning is required.**

Deposits: ☐ None ☐ Mud ☐ Sludge ☒ **Debris** ☐ Grease

Silt Depth: **8** (in.) Deposits Extent: **Heavy**

Infiltration: **Evidence** Pipe Seal Cond: **Unknown**

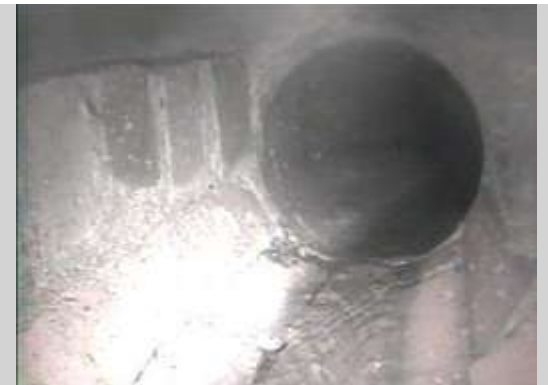
8 in. Circular Gravity Sewer Pipe In @ 6 O'Clock

Infiltration: **Evidence** Pipe Seal Cond: **Unknown**
